## RESEARCH MEMORANDUM

MECHANISM OF START AND DEVELOPMENT OF AIRCRAFT

CRASH FIRES

By I. Irving Pinkel, G. Merritt Preston, and

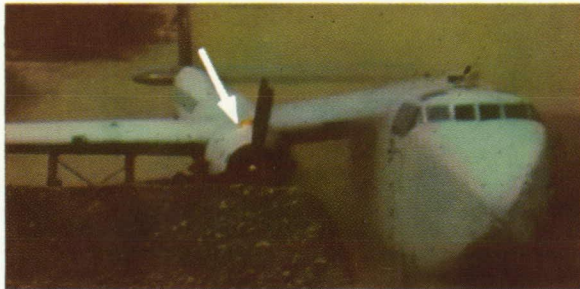
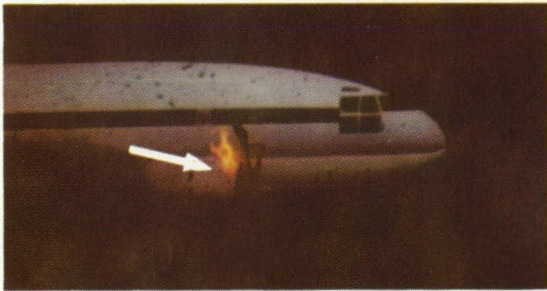
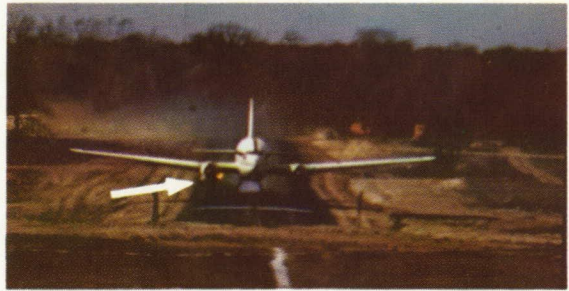
(a) Backfire from engine induction system  
7.7 seconds after initial impact and 3.7  
seconds after end of engine rotation.

(b) Flaming out of induction system inlet  
2.2 seconds after impact with barrier.  
Ignition system cut 2.0 seconds before  
impact.

(c) Exhaust flame resulting from cutting  
of engine ignition system during full-  
power operation.

Figure 7. - Flaming out of engine induction system and exhaust flames from engine exhaust.

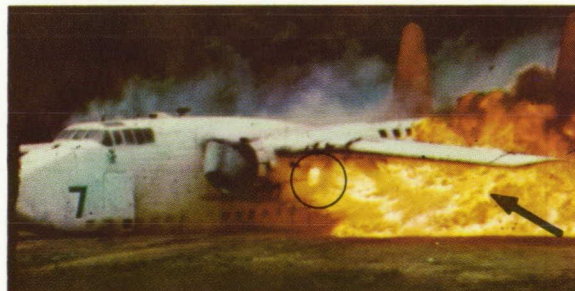
Figure 8. - Largest exhaust flame from engine  
exhaust system observed during crash pro-  
gram; 3.3 seconds after initial impact.

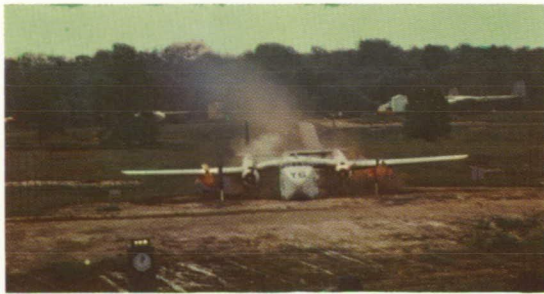
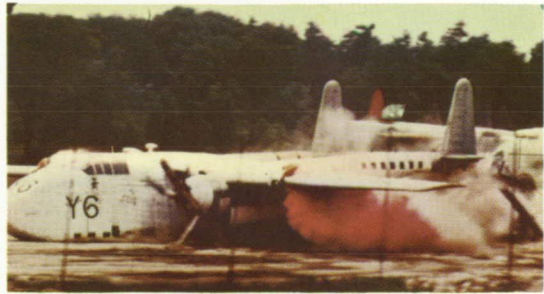
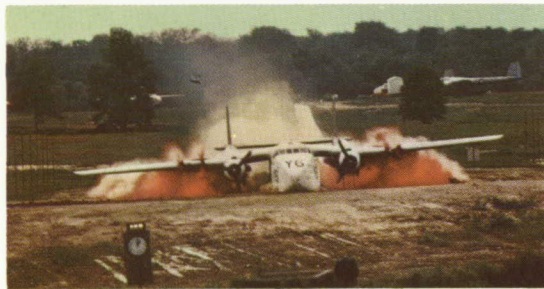
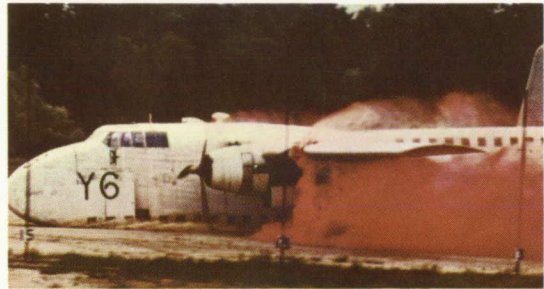
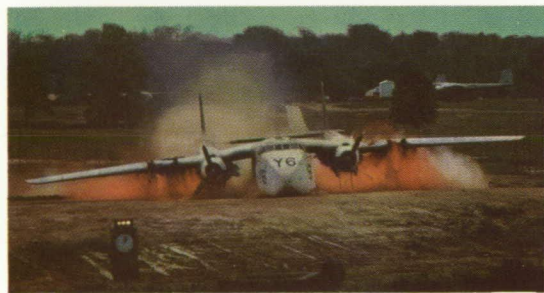
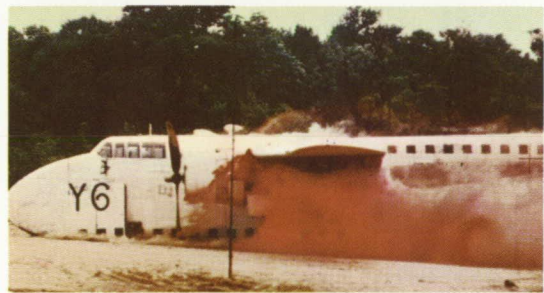
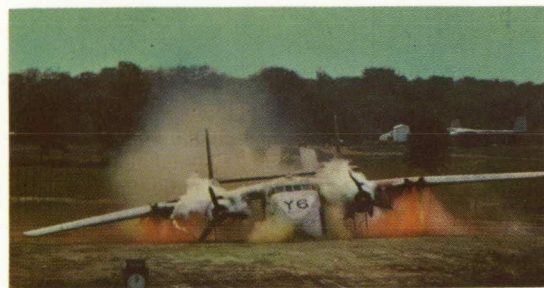
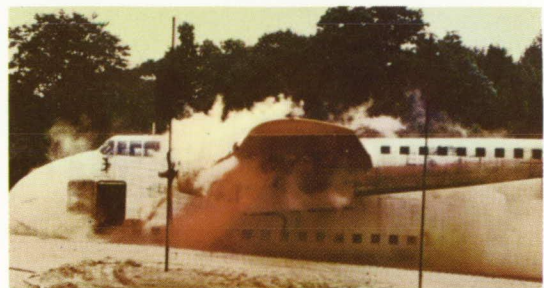
Figure 9. - Development of fuel mist spillage from ruptured wing tanks. (Fuel dyed red.)

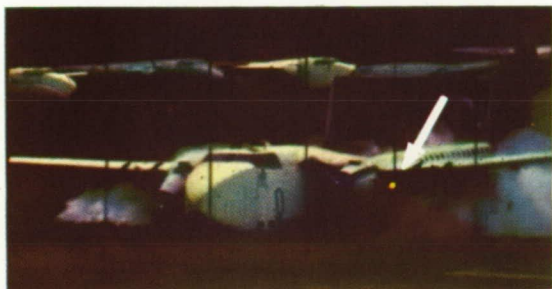
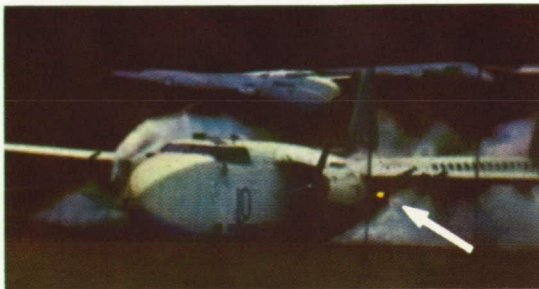
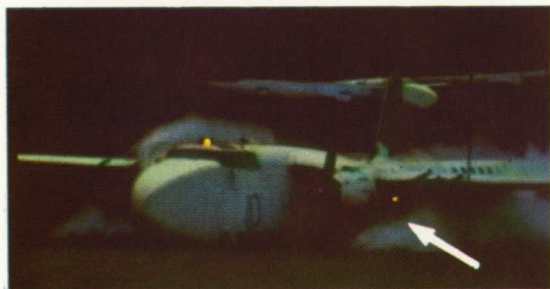
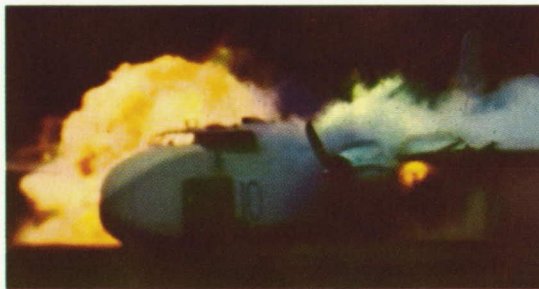
On the left side of this airplane the engine remained in place but fire was ignited by exhaust flames that were described under the section on the mechanism of fuel-mist development shown in figures 12(a) to 12(d). The exhaust flames that were observed were provided by the burning of the fire extinguishing agent employed in the engine induction system. The agent in this case was bromochloromethane ( $\text{CH}_2\text{BrCl}$ ) known as CB. This material decomposes thermally at the temperatures of the engine exhaust system metal and some of the decomposition fragments released will burn in air. Photographs of this agent burning on the surface of a heated section of exhaust stack is shown in figures 39(a) and 39(b). In normal application during fire extinguishment enough CB is employed to provide an inerting atmosphere around the decomposition products and their ignition does not occur. In a crash, unfortunately, there can be no control of the quantity of extinguishing agent passing through the engine because the displacement of the pistons meters the extinguishing agent throughput according to the engine rotational speed and the current throttle setting of the damaged engine, neither of which can be specified in a crash. Although high concentrations of CB were provided at the engine inlet of the crashed airplane, the quantity passed through the engine was small enough to allow a sufficient residence time in the high-temperature environment of the exhaust disposal system to decompose thermally. Upon contact with the air at the tail-pipe exit, the decomposition products ignited to provide the series of exhaust flames shown in figures 12(a) to 12(d).

during the airplane slide from the crash barrier to near rest when ignition of the gasoline mist occurred at the engine tail pipe (fig. 12(d)). Ignition of the gasoline mist by the hot exhaust collector ring, involving a similar time delay, is shown in figure 38(d).

(a) First exhaust flame and spread of fuel mist; 1.1 seconds after initial impact. Airplane speed, approximately 105 feet per second.

(b) Second exhaust flame and spread of fuel mist; 2.0 seconds after initial impact. Airplane speed, approximately 70 feet per second.

(c) Third exhaust flame and spread of fuel mist; 2.2 seconds after initial impact. Airplane speed, approximately 60 feet per second.

(d) Ignition of fuel mist; 4.1 seconds after initial impact. Airplane speed, approximately 10 feet per second.

Figure 12. - Ignition of fuel mist by exhaust flames from exhaust outlet.

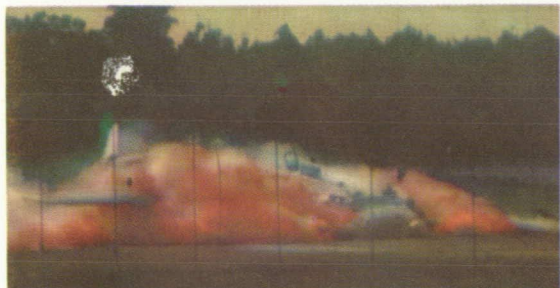
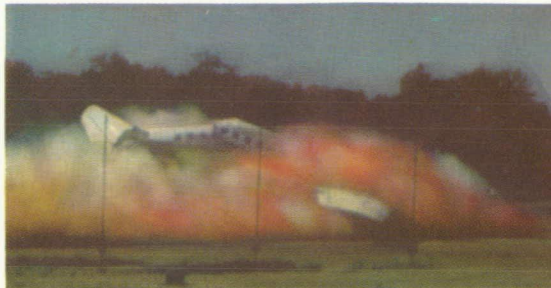
An example of an extreme forward development of the fuel mist obtained during a crash involving high airplane decelerations is shown in figures 16(a) and 16(b). The fuel mist extended 28 feet ahead of the wing and reached a height of 12 feet above the top of the wing.

In order to establish the difference in velocity between the airplane and the tank fuel required for the fuel to project ahead of the airplane, the airplane deceleration must be sustained for a time that varies inversely with the magnitude of deceleration. In the case shown in figure 16, 0.3 second after the airplane nose struck the ground, which represents the onset of high deceleration, fuel appeared at the leading edge of the wing with an initial velocity of approximately 30 feet per second with respect to the airplane wing. One second later the fuel achieved an extension of 28 feet ahead of the wing. In the high-deceleration phase following impact of the nose the wing reached a momentary peak deceleration of 20 g.

Figure 16. - Example of extreme forward and spanwise fuel mist development obtained during crash involving high airplane decelerations. Airplane speed, approximately 40 feet per second. (Fuel dyed red.)

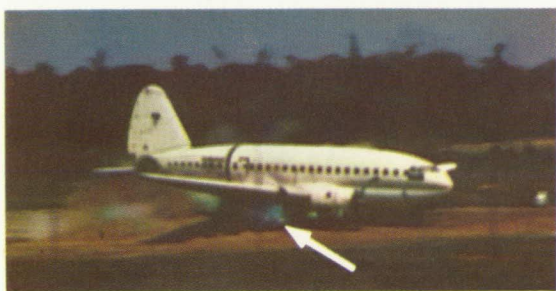
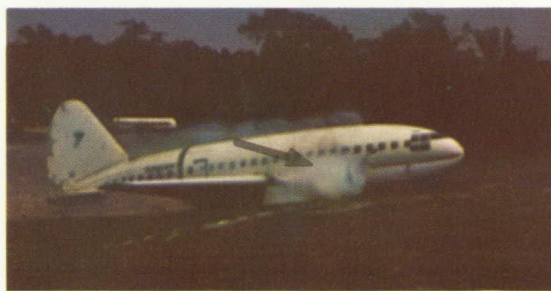
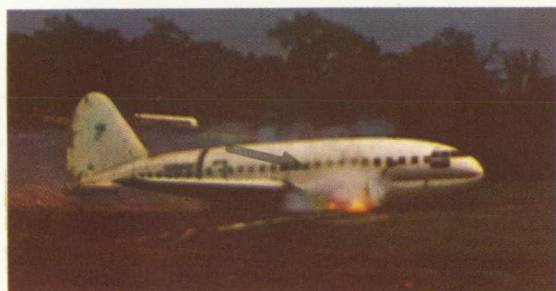
The ignition of the fuel distributed in this manner by an oil fire in the nacelle forward of the wing leading edge is illustrated in figures 17(a) to 17(f). The nacelle installation of the airplane used in this crash (fig. 18(a)) shows an oil cooler located at the bottom of the nacelle directly behind the exhaust collector ring. Shortly after the airplane passed through the poles at the crash barrier, the fuel spilling from the wing tanks has the pattern shown in figure 17(a), which is associated with low airplane deceleration and high airplane speed sketched in figure 14(a). When the airplane nacelles struck the ground the oil coolers were broken away from the oil lines and oil poured on the exhaust collector ring (fig. 18(b)). The airplane decelerations resulting from the friction and plowing of the airplane structure along the ground provided a fuel mist pattern whose apex led the wing leading edge, as shown in figure 17(b), in contrast to the fuel spillage pattern at the crash barrier, which was well behind the wing leading edge (fig. 17(a)). At 1.9 seconds after impact at the barrier, the airplane instrumentation indicated a small oil fire at the base of the exhaust collector ring (fig. 18(b)). Visible in the photograph taken shortly after this time (fig. 17(b)) are dense clouds of condensed oil vapor issuing from the nacelle. The spilling fuel can be seen pouring forward of the leading edge of the wing in contrast to its earlier position under the wing at higher airplane speeds, as shown in figure 17(a). In figure 17(b) fuel mist and condensed oil vapor merge to form a continuous combustible atmosphere at the reduced airplane speed of 3 feet per second. As the airplane slowed, the fuel pattern increased its forward extension (fig. 17(c)) until just before the airplane came to rest the fuel extended to the nacelle. Propagation of the oil fire through the dense condensed oil vapor cloud issuing from the nacelle provided the fuel ignition close to the nacelle shown in figure 17(d). The fuel mist and condensed oil vapor suspended in the air around the airplane were made visible to the camera by the flame that traveled through them (figs. 17(e) and 17(f)).

(a) Fuel mist; 0.5 second after initial impact. Airplane speed, approximately 95 feet per second.

(b) Oil vapors emerging from nacelles; 3.38 seconds after initial impact. Airplane speed, approximately 3 feet per second.

(c) First oil fire outside of nacelle; 3.42 seconds after initial impact. Airplane speed, 2 feet per second.

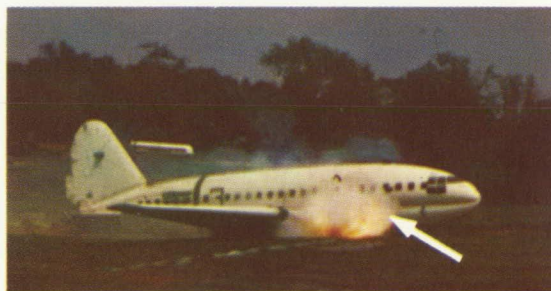
(d) Ignition of fuel mist by oil fire; 3.5 seconds after initial impact. Airplane speed, 0.

Figure 17. - Role of oil system in aircraft crash fires.

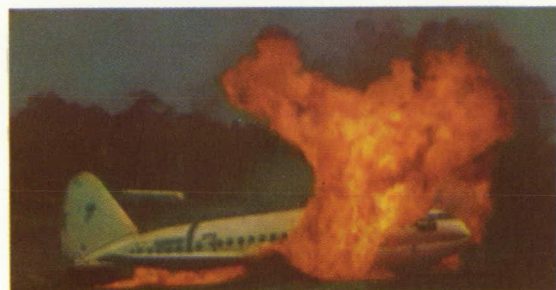
(e) Spread of fuel mist fire; 5.3 seconds after initial impact.

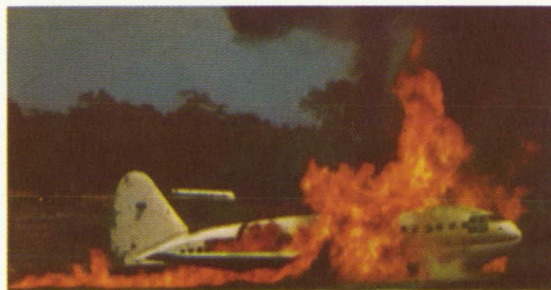
(f) Spread of fuel mist fire; 6.6 seconds after initial impact.

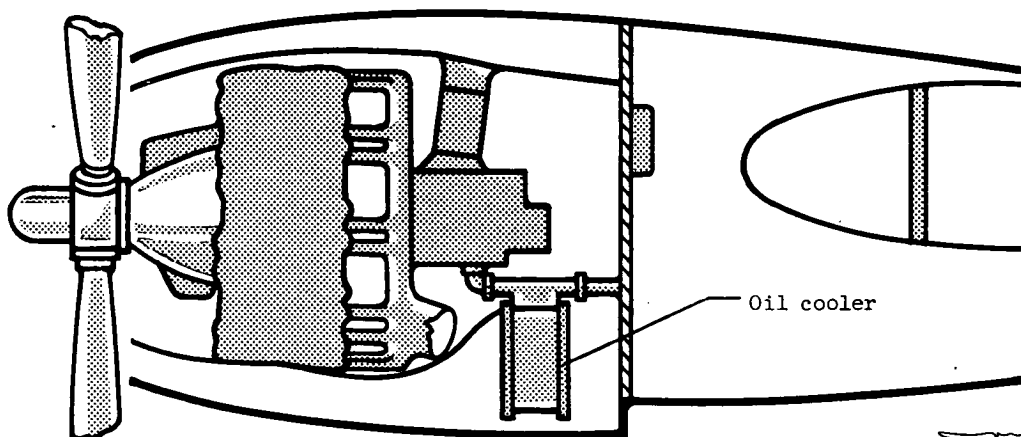
(a) Nacelle configuration.

Figure 18. - Schematic drawing of C-46 airplane nacelle showing oil-cooler location and oil-line rupture in crashes.

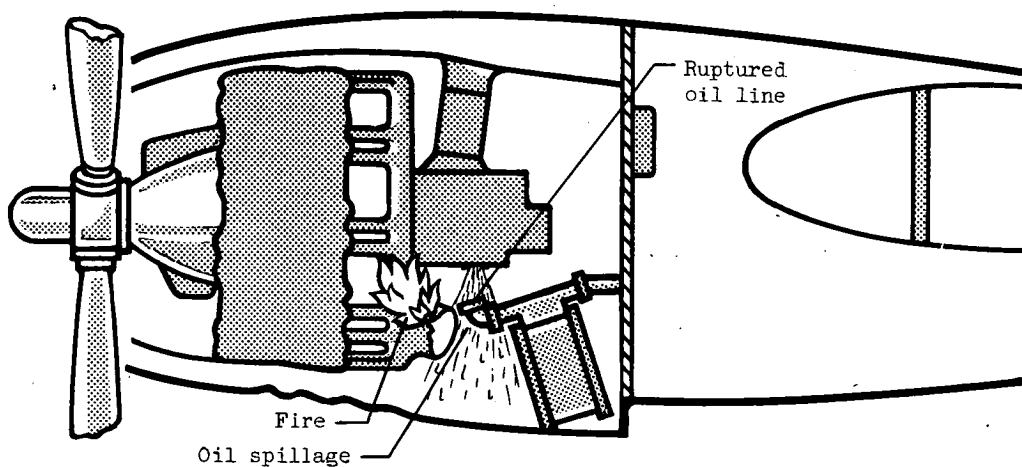
(b) Oil line rupture and initial oil fire on exhaust collector ring 1.9 seconds after initial impact.

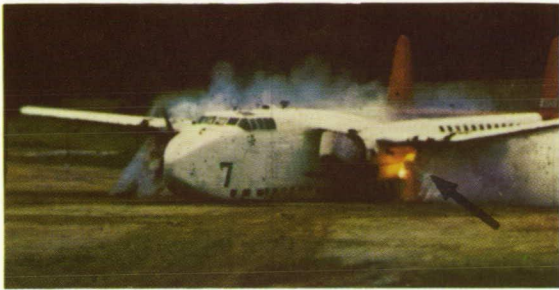
The substitution of low-volatility fuel for gasoline does not materially reduce the likelihood of ignition when contact between the fuel mist and a potent ignition occurs. The ignition of the mist of low-volatility fuel at the engine tail pipe is shown in figure 19. The large fuel mist fire on the left side of the airplane (fig. 19(b)) followed the ignition  $1\frac{1}{2}$  seconds earlier in figure 19(a). These results indicate that fuel of low volatility will ignite and burn readily when dispersed as mist, and their adoption for reciprocating engines alone would not represent a wholly acceptable solution to the crash-fire problem.

(a) Ignition left nacelle, test 7; 2.0 seconds after initial impact. Airplane speed, approximately 98 feet per second.

Figure 19. - Ignition of fuel mist by exhaust flames from exhaust outlet. Low-volatility fuel.

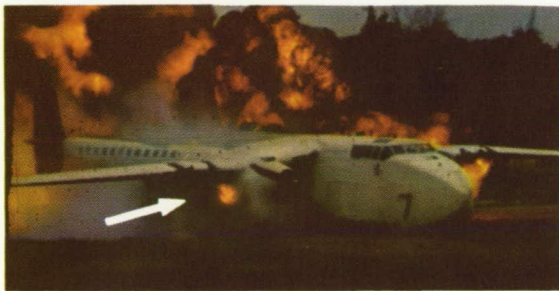
The engine induction system fuel can be ignited from within the engine by the ordinary backfire mechanism. If the engine induction system is ruptured before the backfire occurs the resulting flash may appear within the nacelle cowl and play the same role in setting the crash fire as the induction system fuel played in the fire just described. While no airplane fires occurred by this backfire ignition of the induction system fuel in the crashes conducted so far, the distinct possibility of setting fires in this way is shown by the under-cowl induction system fire shown in figures 33(a) and 33(b). The disarranged engine cowl in its displacement from its normal position severed the engine cowl inlet connection to the carburetor and provided an opening through which the engine induction system fire appeared within the nacelle, 3.5 seconds after crash. In this instance the fuel involved was the low-volatility (8 mm Hg Reid vapor pressure) fuel. The circumstance just described occurred in the crash discussed previously in conjunction with figure 19.

(b) Ignition right nacelle, test 7; 3.5 seconds after initial impact. Airplane speed, 50 feet per second.

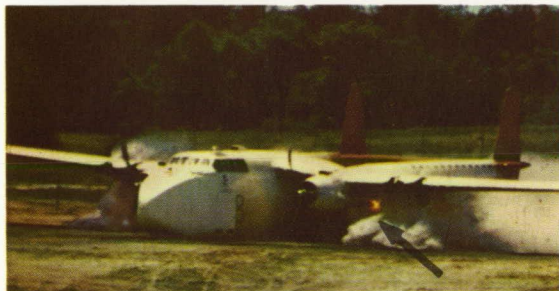
was employed provided a fuel mist ignition at reduced airplane speed under similar circumstances on the right side of the airplane (fig. 19(c)). Exhaust flames did not appear on the right engine nacelle in this crash and fuel ignition did not take place.

Cross-over of fire did take place, however, along the liquid fuel path left in the trail of the crashed airplane and on the airplane itself. In one crash of an airplane carrying fuel of low volatility (8 mm Hg Reid vapor pressure) fire occurred on the left side, as shown in figure 19(c). The fire, as it appeared on the right side as the airplane came to rest, is shown in figure 62. Only the fabric of the empennage control surfaces, ignited by the fuel mist flash fire, is burning on this side. Fire traveled to the right side of the airplane along the rivulet of fuel running from the right wing tanks downhill to the fire burning in the skid path of the airplane on the left side 60 feet behind the airplane empennage. The fire that moved along this fuel rivulet on the ground is shown in the succession of photographs in figures 66(a) to 66(d). The right wing became involved in the fire approximately 107 seconds after the crash. That propagation of the fire forward through the thin mist of low-volatile fuel suspended in the air on the right side of the airplane did not occur is probably related to the relative advantage low-volatility fuel confers under these circumstances as shown by the data of figure 22 on maximum distance from the mist source for upwind flame propagation.

(c) Ignition left nacelle, test 8; 1.9 seconds after initial impact. Airplane speed, 74 feet per second.

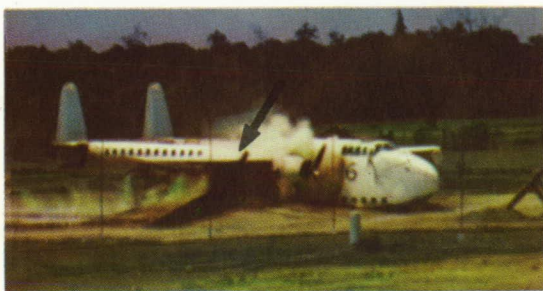
(a) Impact of poles with landing lights; 0.25 second after initial impact. Airplane speed, 143 feet per second.

Figure 24. - Ignition of fuel by landing lights.

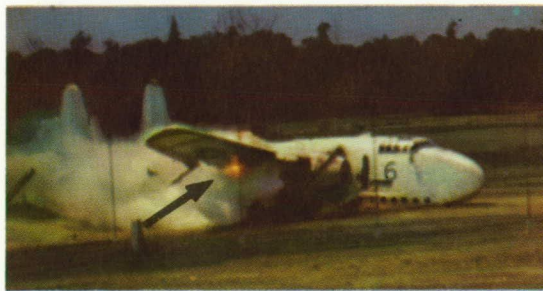
(b) Ignition on right side of airplane; 0.60 second after initial impact. Airplane speed, 135 feet per second.

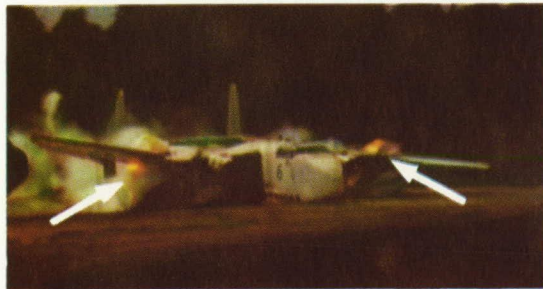
Ignition sources within the wing belong to the wing electrical system. Damage to this electrical system during crash impact can produce ignition sources close to the wing fuel spillage, and fire follows almost at once. In figure 24(c) is shown the fire produced by operating landing lights which are smashed and driven into the wings by the poles at the crash barrier. The wing fire appeared 0.60 second after crash impact.

(c) Simultaneous ignition of both sides of airplane; 0.60 second after initial impact. Airplane speed, 135 feet per second.

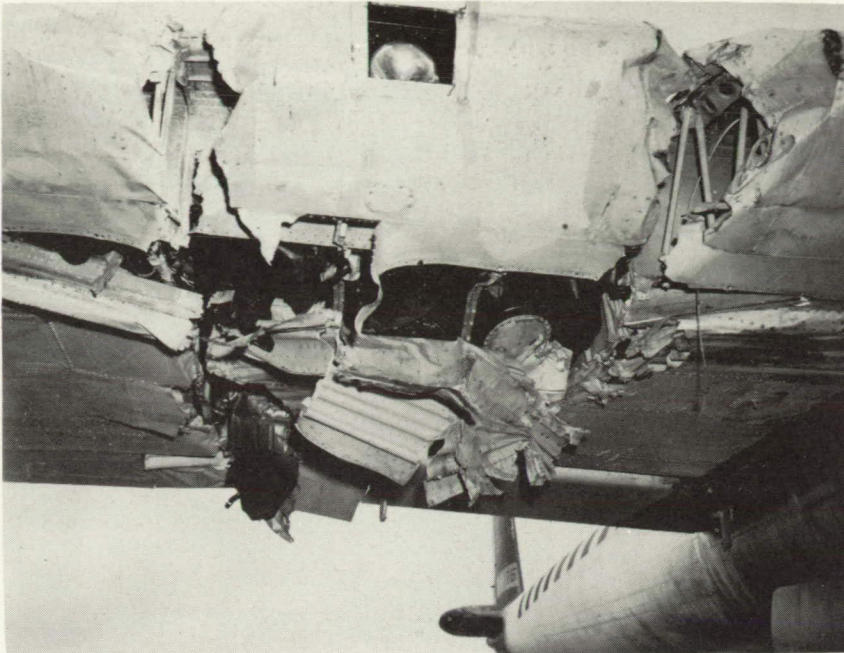
(a) Rupture of wing produced by pole barriers.

Figure 25. - Mechanism of ignition of liquid fuel flowing through hot-air anti-icing duct.

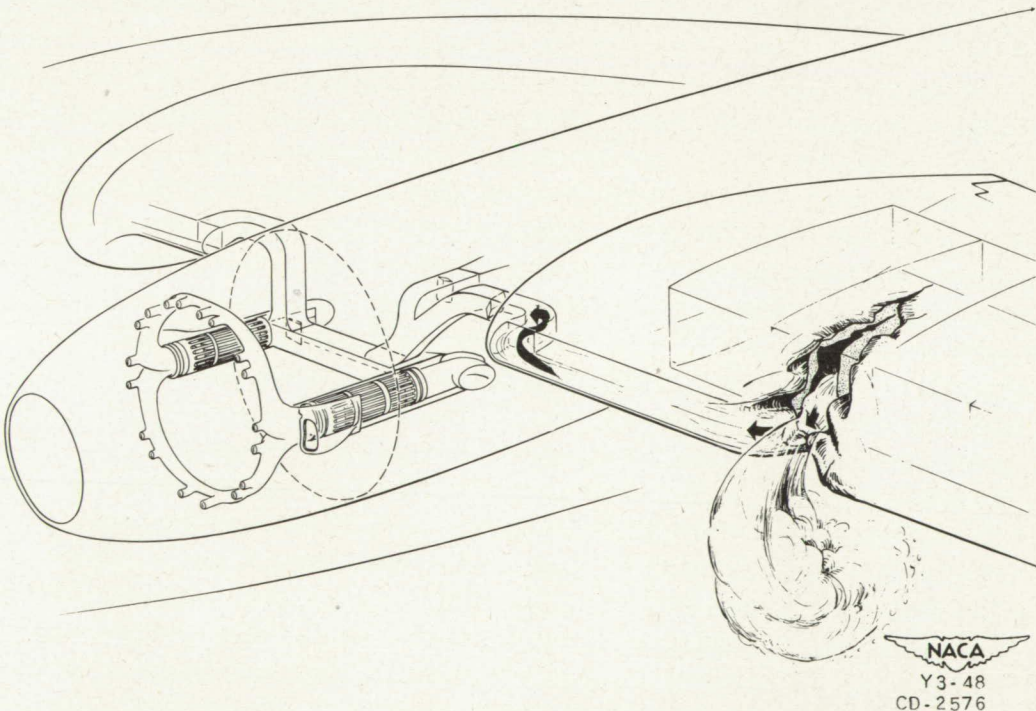
(b) Schematic diagram of hot-air anti-icing system showing path of liquid fuel flowing from wing tanks to heat exchangers.

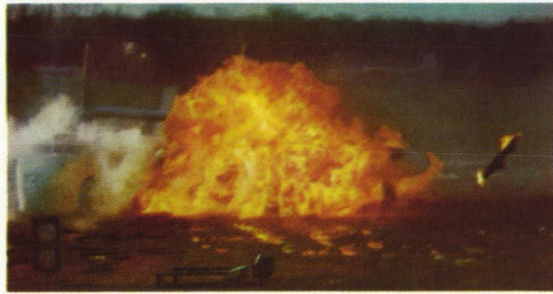
away from the fuel spillage point. Hot-gas ducts of the icing protection systems or cabin air conditioning for example, lead to heat exchangers which are often at temperatures above the fuel ignition temperature. In figure 25(c) is shown the fire that follows the movement of wing-spilled fuel through the icing system hot-gas distribution duct which runs along the wing leading edge to the engine exhaust gas heat exchanger on the engine tail pipe below the wing (fig. 25(b)). Propagations of the fire into the wing above the path of fuel produced the wing explosion shown in figure 25(c). Because of the time required for the fuel to move to the ignition source, this fire occurred 12 seconds after crash impact.

(c) Explosion of wing following ignition of gasoline flowing through anti-icing duct; 13 seconds after initial impact; 0.6 second after ignition.

Figure 25. - Concluded. Mechanism of ignition of liquid fuel flowing through hot-air anti-icing duct.

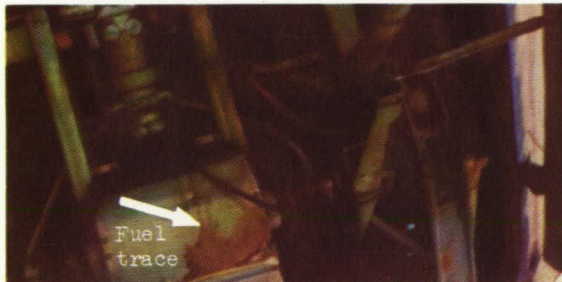
(a) Wheel well.

Figure 26. - Distribution of fuel throughout wheel well and on landing gear strut from wing-tank spilled fuel. (Fuel dyed red.)

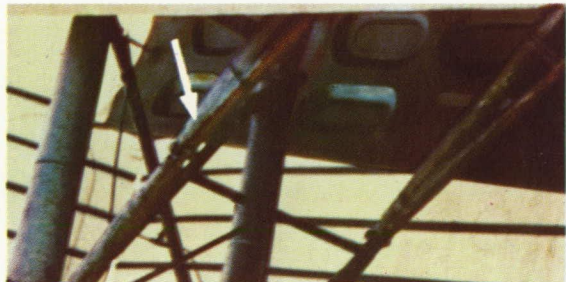
(b) Landing gear strut.

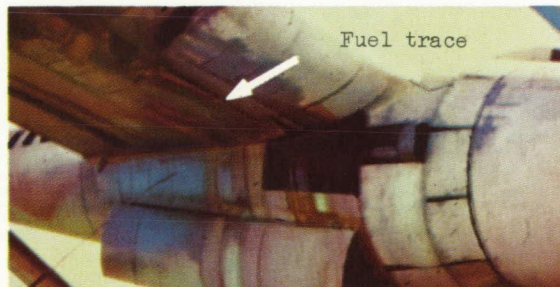
Distribution of fuel in liquid form from the spillage point to remote areas can take place on the lower surfaces of inclined elements of the airplane structure. The liquid fuel wets and clings to these surfaces, such as the lower wing skin, and flows by gravity. This so-called "wetting conduction" of the fuel is shown in figure 27 on the wing and nacelle and in figures 26(a) and 26(b) in the elements of the wheel well and landing gear strut. The red dye trails left by the fuel show the wetted path of the fuel. Because of the wing dihedral, the fuel tends to move to the nacelle where many ignition sources are located if the wing position is not altered from normal in the crash.

Figure 27. - Wetting conduction trail of fuel on under side of airplane wing. (Fuel dyed red.)

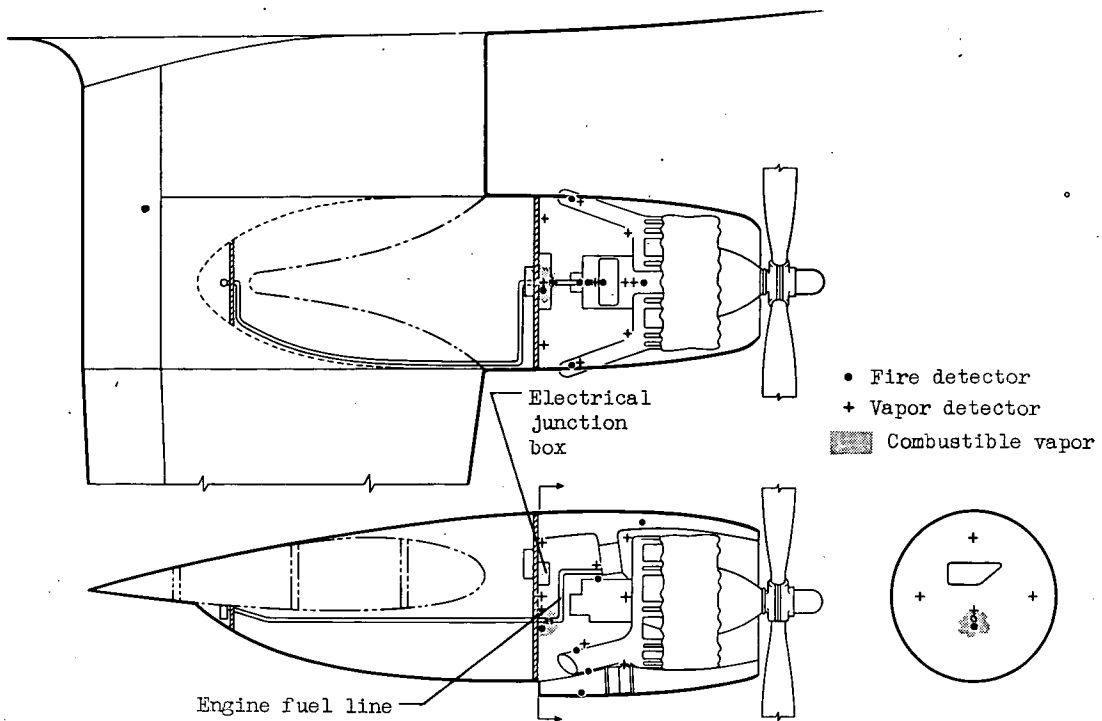
(a) Location of vapor and fire detectors in nacelle and combustibile vapor detected 1/4 second after initial impact.

Figure 28. - Mechanism of ignition by electrical system in accessory section of airplane nacelle.

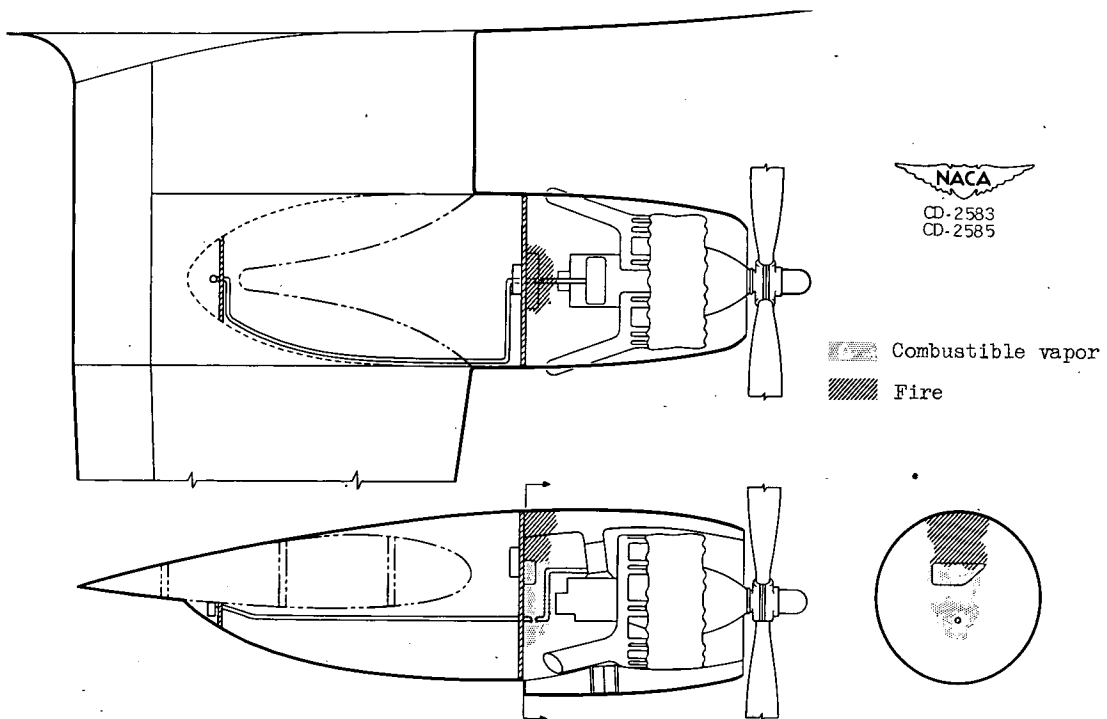
(b) Combustibile vapor and fire detected in nacelle 1 second after initial impact.

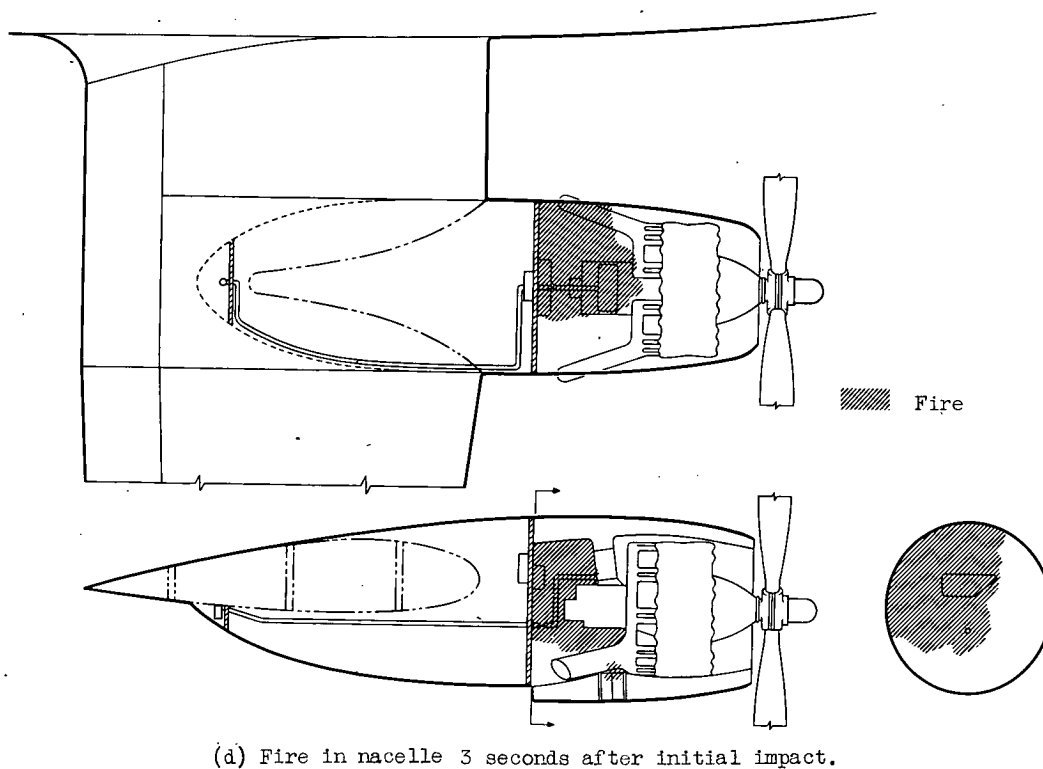
Figure 28. - Concluded. Mechanism of ignition by electrical system in accessory section of airplane nacelle.

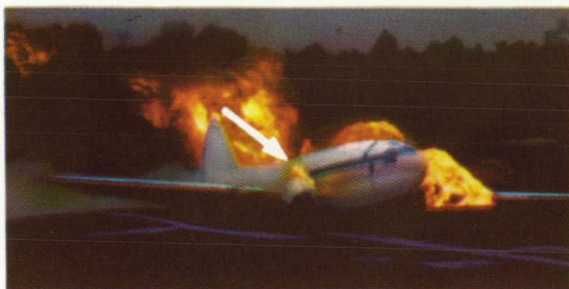
(a) Fire 2.8 seconds after initial impact. Airplane speed, 42 feet per second.

Figure 29. - Extension of fire from nacelle to fuel spilled from wing tanks.

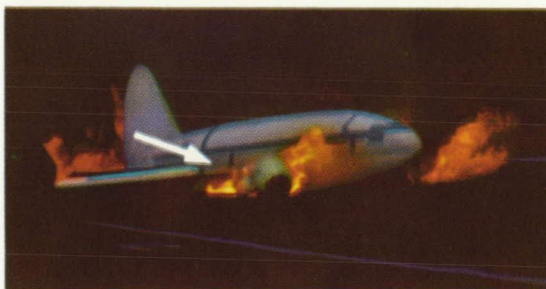
(b) Fire 7.4 seconds after initial impact. Airplane speed, 0.

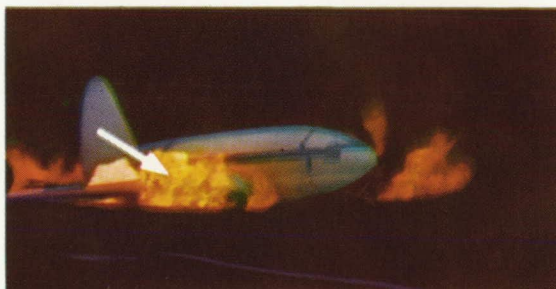
(c) Fire 7.7 seconds after initial impact.

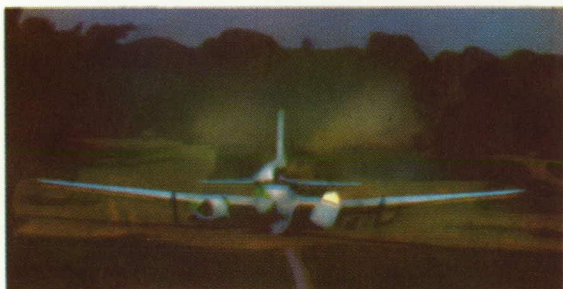
The fuel that is spilled as carburetted mixture of fuel and air from the damaged engine induction system is generally released in zones adjacent to the hot exhaust disposal system and the electrical elements in the engine accessory sections. A variety of ignition sources are available, therefore, to ignite this fuel. The quantity of fuel in the engine induction system is too small to produce a serious fire unless the flash fire of this fuel extends to other fuel spillage. In figure 30 is shown the propagation of the engine induction system fuel fire out of the nacelle to the fuel spillage from the wing.

(a) Ignition of induction system vapor-air mixture; 0.13 second after initial impact. Airplane speed, 115 feet per second.

Figure 30. - Spread of fire resulting from ignition of vapor-air mixture in induction system.

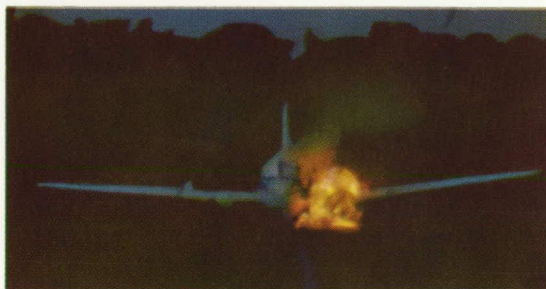
(b) Ignition of engine fuel from broken main fuel line in nacelle; 0.29 second after initial impact. Airplane speed, 111 feet per second.

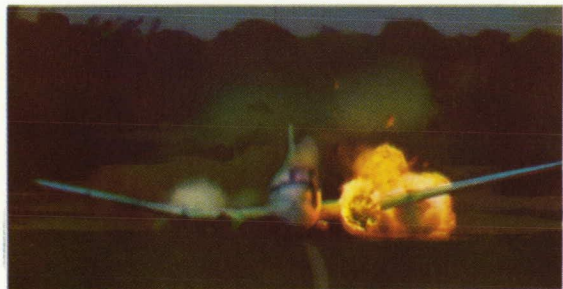
(c) Ignition of fuel mist from fuel tanks spillage; 0.71 second after initial impact. Airplane speed, 102 feet per second.

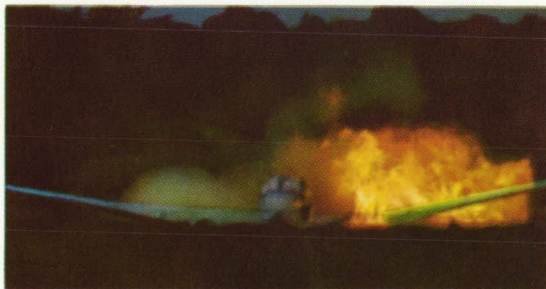
(d) Spread of fire in fuel mist; 1.2 seconds after initial impact. Airplane speed, 89 feet per second.

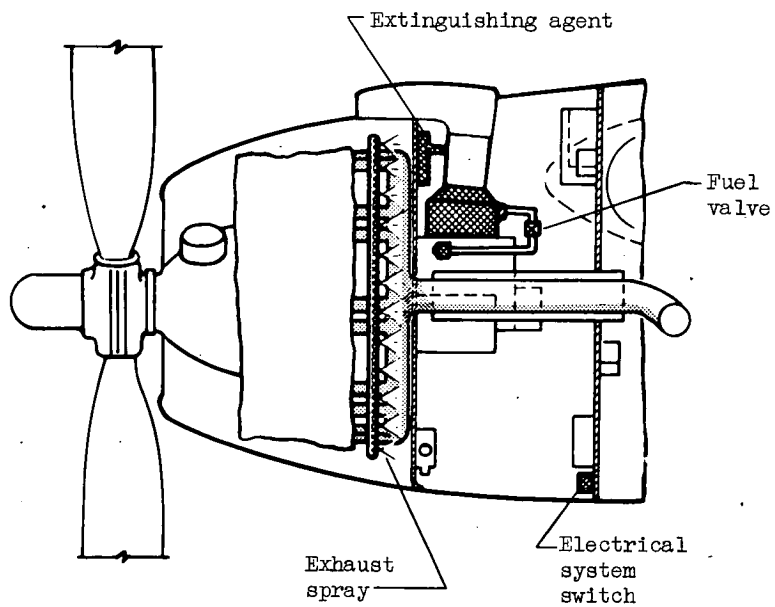
Figure 31. - Schematic diagram of ignition source inerting system.

masking other fire setting mechanisms which would appear later in the crash. In an effort to prevent these early fires, therefore, the nacelle installation shown schematically in figure 31 was employed to reduce the likelihood of fire by ignition sources revealed in previous airplane crashes.

In an effort to reveal mechanisms of crash-fire initiation that may have been obscured by the early fires set by the known ignition sources, an ignition source inerting system was installed in nacelles of several aircraft crashed in this program. A schematic view of the inerting system arrangements is given in figure 31. The four-component inerting system includes a fuel shut-off valve at the carburetor and fire wall which serves to bring the engine to rest, a 3-pound charge of fire extinguishing agent injected with the engine inlet to inert the engine interior, an electrical system cut-off switch on the battery and generation circuits to prevent the development of hot wires and electric arcs, and a water-spray system that is arranged to distribute water to

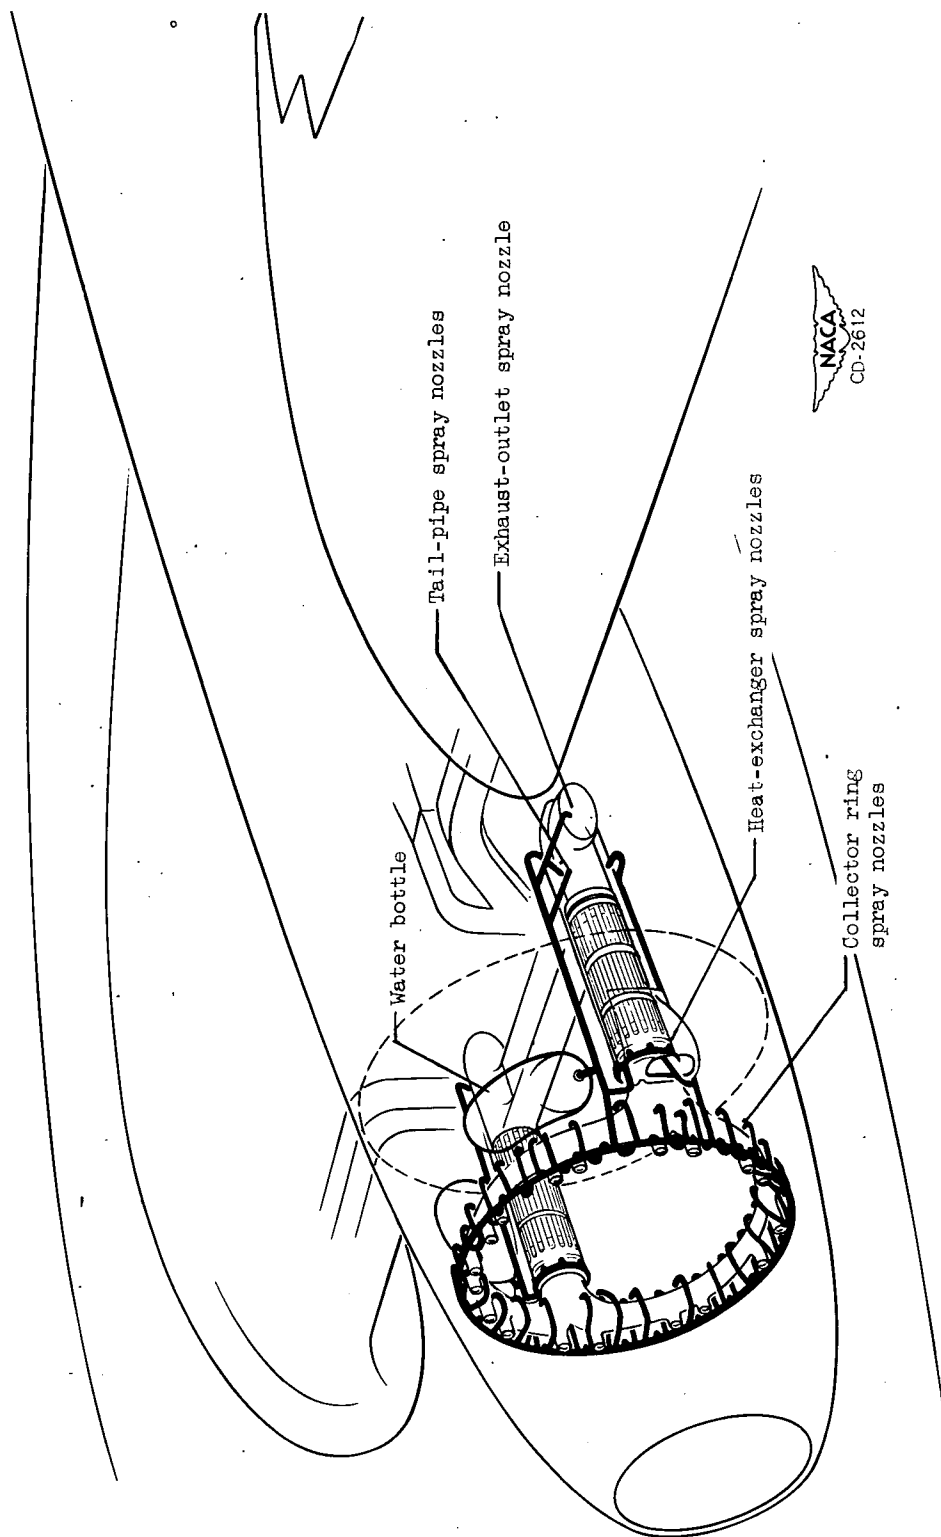
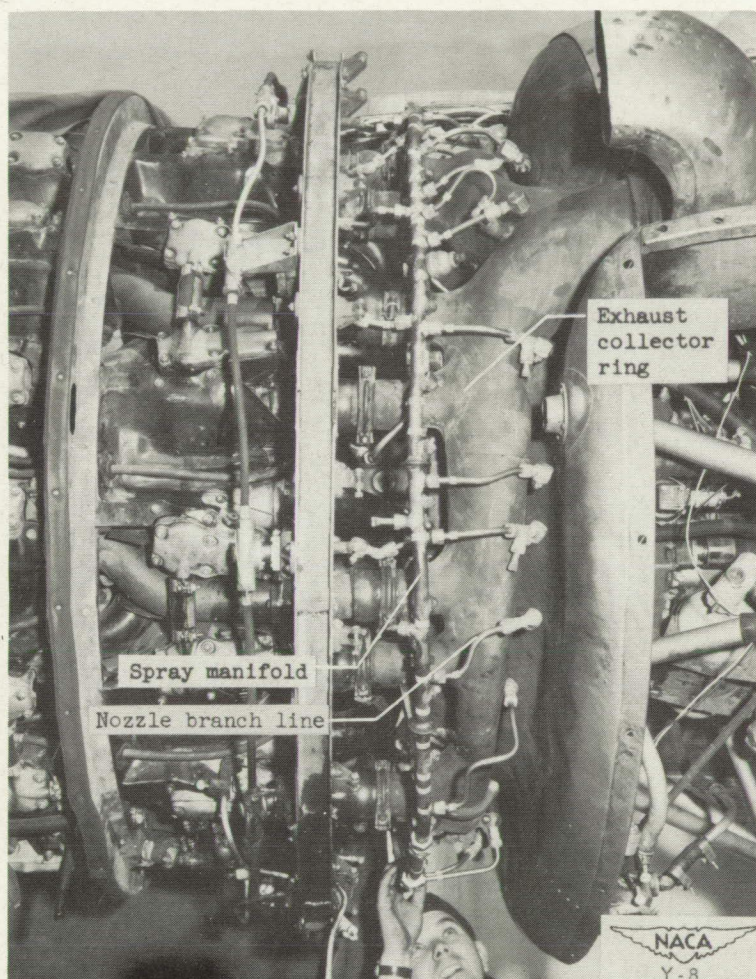
Figure 32. - Water spray system of ignition source inerting system.

The essential elements of the water spray system are shown schematically in figure 32(a). The water, contained under nitrogen pressure of approximately 400 pounds per square inch, was distributed to all hot

(a) Schematic diagram of nacelle installation.

(b) Exhaust collector ring water spray system.

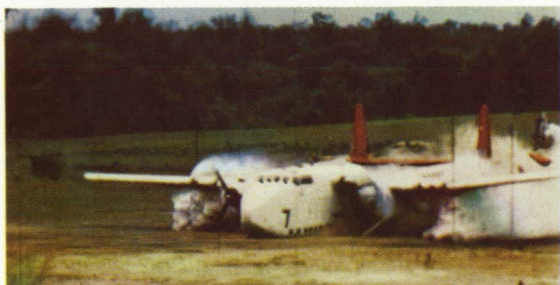
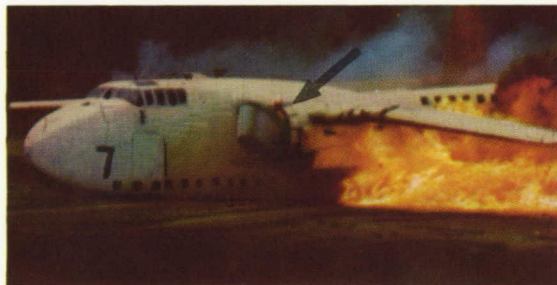
Figure 33. - Delayed ignition of induction-system fuel.

(a) Engine cowl disruption at barrier; 1.0 second after initial impact. Airplane speed, 130 feet per second.

(b) Induction-system fuel ignition 3.5 seconds after initial impact. Airplane speed, 50 feet per second.

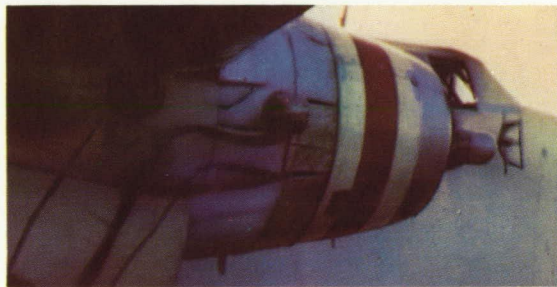
Figure 34. - Tests of water sprays of ignition-source inerting system.

(a) Oil fire before water sprays turned on.

(b) 1.0 second after water sprays turned on oil fire.

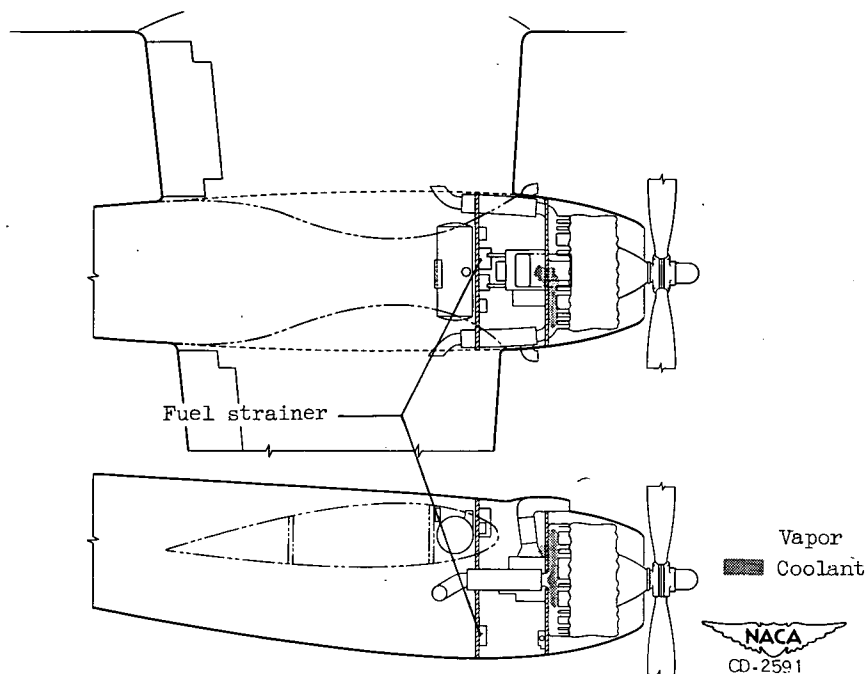
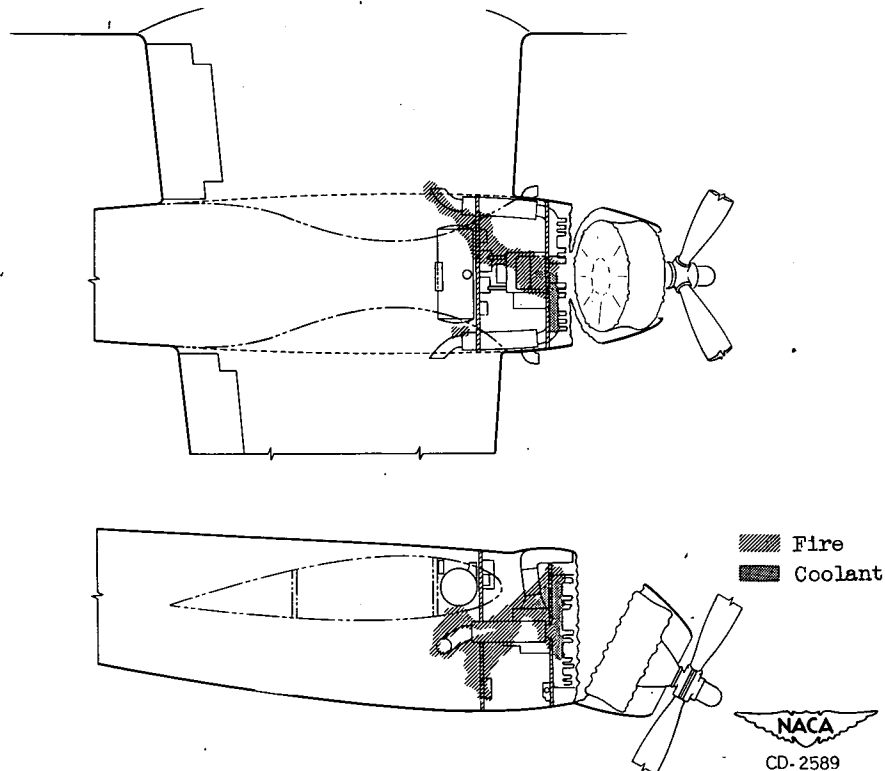
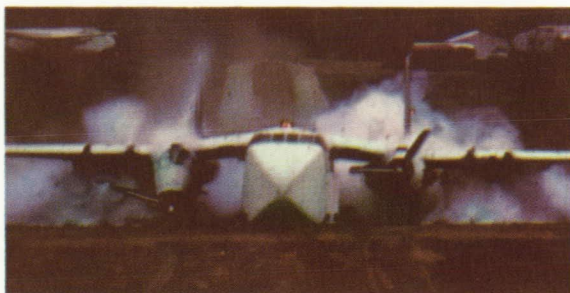
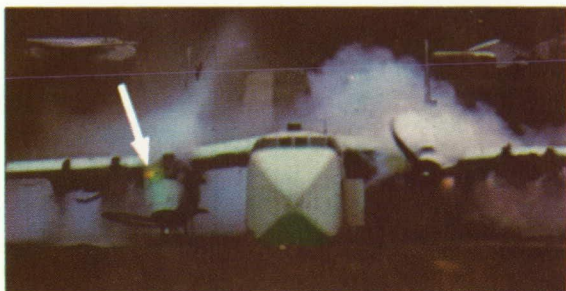
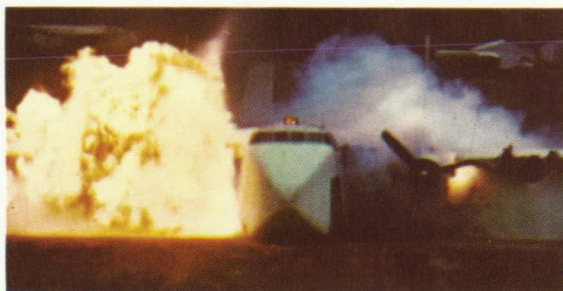
Figure 38. - Mechanism of ignition by hot metal of exhaust collector ring.

(b) Schematic diagram of nacelle showing location of combustible vapor and coolant in nacelle 0.75 second after initial impact.

(c) Schematic diagram of nacelle showing fire indicated by detectors in nacelle 4.2 seconds after initial impact.

(a) Deformation of right engine nacelle 2.2 seconds after initial impact. Airplane speed, 60 feet per second.

(d) First indication of fire on right nacelle 3.8 seconds after initial impact. Airplane speed, 15 feet per second.

(e) Fire development 4.1 seconds after initial impact; 0.3 second after ignition. Airplane speed, 11 feet per second.

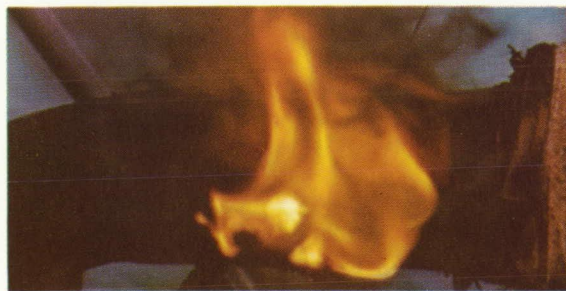
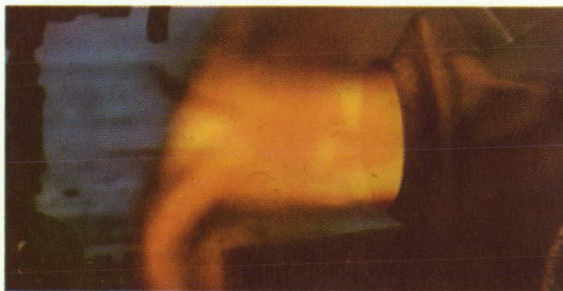
(a) Bromochloromethane burning on outside of heated stack.

(b) Bromochloromethane burning on inside of heated stack.

Figure 39. - Bromochloromethane burning after ignition by section of exhaust stack heated to 1500° F.

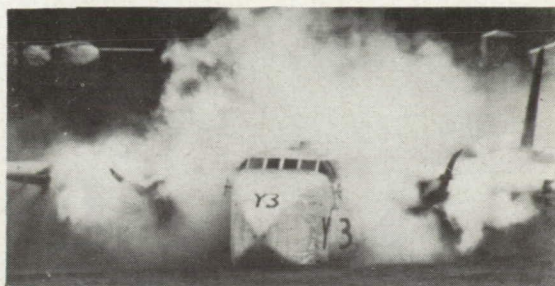
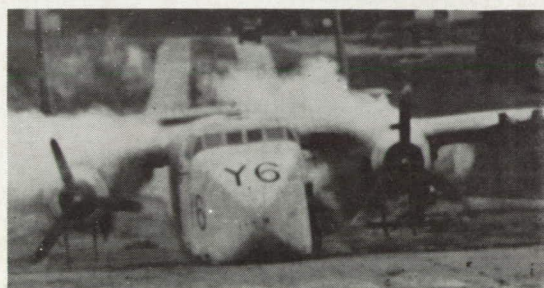
Five of the airplanes equipped with the inerting system that did not burn are shown in figure 40, taken when the airplanes came to rest after crash. A sixth airplane, likewise equipped, was subjected to a ground loop (fig. 41) and did not burn either.

Figure 40. - Appearance of airplanes following crash without fire.
